DMC
GROUP
ENABLING WORKS CONTRACTOR

Case Study / Seven Dials.

Case Study / Vogue House.

Cladding Division Case Study / Salix Court, Salford / Rainscreen & Floor Spanning System.

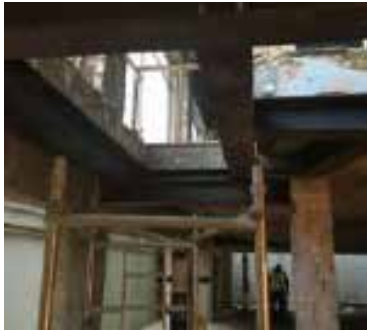
Structural Steels

In the basement area, DMC were required to remove a safe deposit room and make good any openings left including the concrete floor. There was also a strong room located in the basement and 2 staircases accessing the basement from the ground floor. During these works, we were required to install structural steel beams to ensure that the original bearing capacity was achieved.

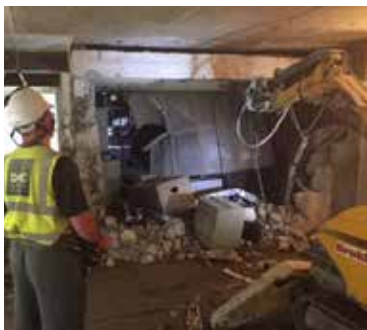
Basement Works

Due to height restrictions in this area and minimal access, DMC employed the use of a BROKK excavator. The use of this specialised equipment meant that removal works could be carried out within the low ceiling height, effectively and efficiently.

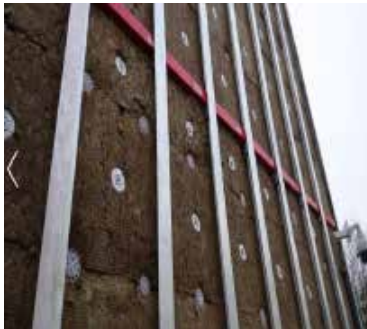
This floor spanning over cladding system was supplied by System Building Products and installed on location by DMC Group.

The design has been carried out Mark Heywoods Associates in accordance with British standard codes on wind loading, Structural use of aluminium, corrosion at bimetallic contacts and method of testing for structural fixings.

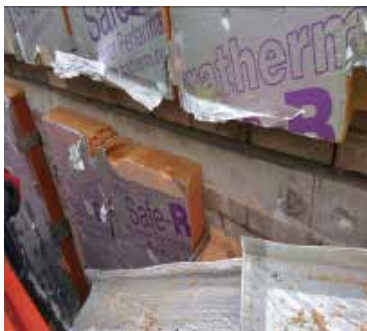
Work commenced by removing Reynabond pannels from the gable end of Salix Court. Once the task had been completed the operatives then began to remove each T rail from the carrier system along with insulation and fire break to expose the buildings brick work. Any historic penetrations in the brick substrate were then injected with EPDM sealant to protect the structure from water and air ingress.

Dead load brackets were then installed using Fischer FIS V 360s resin and stainless steel A40-70 Threaded rod. Brackets were then installed at designed increments to first floor slab along with helping hand brackets to the second-floor slab.

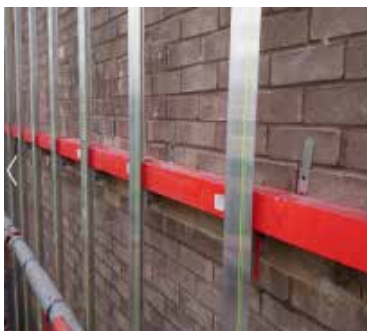
Teflon coated fixings and washers were used on the systems components to reduce friction and provide isolation between dissimilar materials.

Once the installation of the T rails to the brackets had been completed operatives lined and levelled the grid before installing Tenmat Ventilated Fire Barrier at floor slab level.

A constant 30mm air gap was maintained between the intumescent strip and the back of the support rail to allow for free air flow with in the compartments.

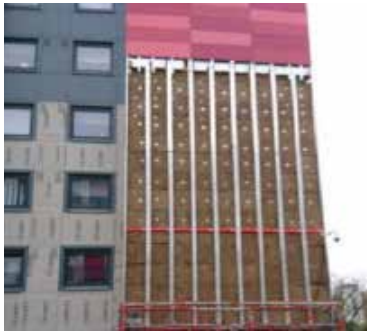
Once installation of the Fire break had been completed operatives then began installing 110mm Knauf Earthwool Dritherm Cavity Slab to the brick substrate. The insulation was then directly fixed to the building using 6 number plastic tie back fixings with spreader washer and 2 number stainless steel fire rated insulation fixings.

An expansion joint has been installed at every second level to allow for deflection of the internal slab or expansion and contraction of the façade system.
